CORRECT BEARING INSTALLATION IN CLUTCH FORK

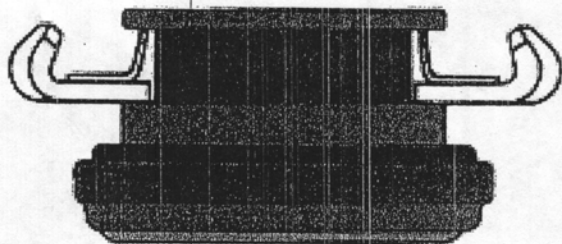
Correct installation

A common cause of release bearing failure and non-release of clutches is improper installation in the clutch fork. The spring clips MUST be installed in the bearing slot and not around the rear of the bearing in order for the clutch to function properly.

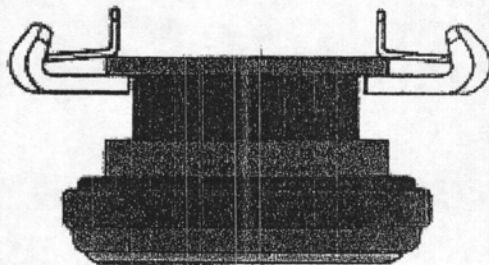
Incorrect installation
