- **GLASS—HEATED BACKLITE INOPERATIVE—TERMINAL SEPARATES FROM GLASS OR GRID BREAKS**
- **HEATED BACKLITE—INOPERATIVE—TERMINAL SEPARATES FROM GLASS OR GRID BREAKS**

**Article No.
93-26-1**

ISSUE: An inoperative electric rear window defroster (heated backlite) may be caused by bond separation of the pigtail terminal to bus bar or broken grid lines.

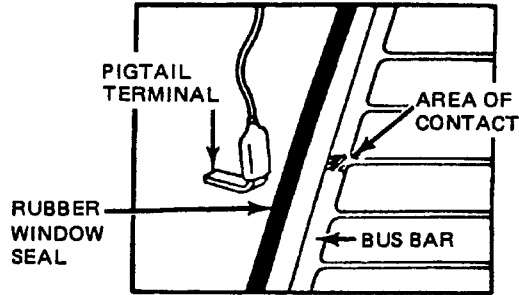
1. PROBLEM

TERMINAL REPAIR

ACTION: Use a rear window defroster service kit to repair pigtail connections, Figure 1 and grid line breaks, Figure 2.

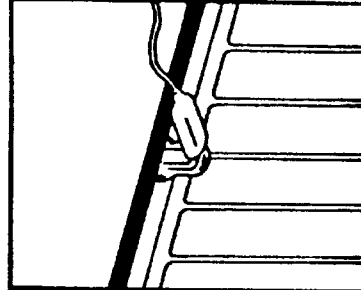
4. SOLUTION

Figure 1 - Article 93-26-1

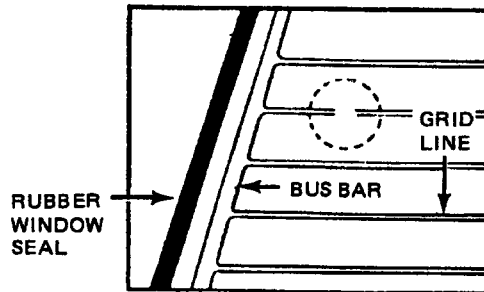
1. PROBLEM

GRID REPAIR

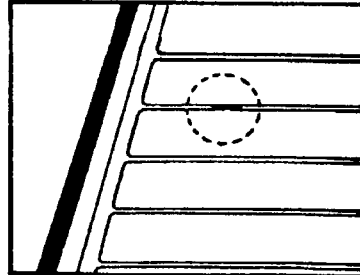
4. SOLUTION

Figure 2 - Article 93-26-1
