OPR Turn Signal/Windshield Wiper Assembly (87-89) Install Guide

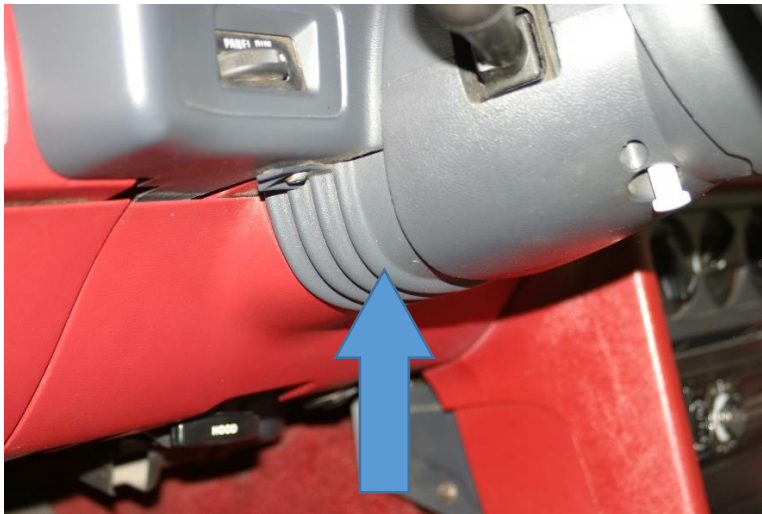
Picture 1: Tilt Cover in position as indicated by the blue arrow.

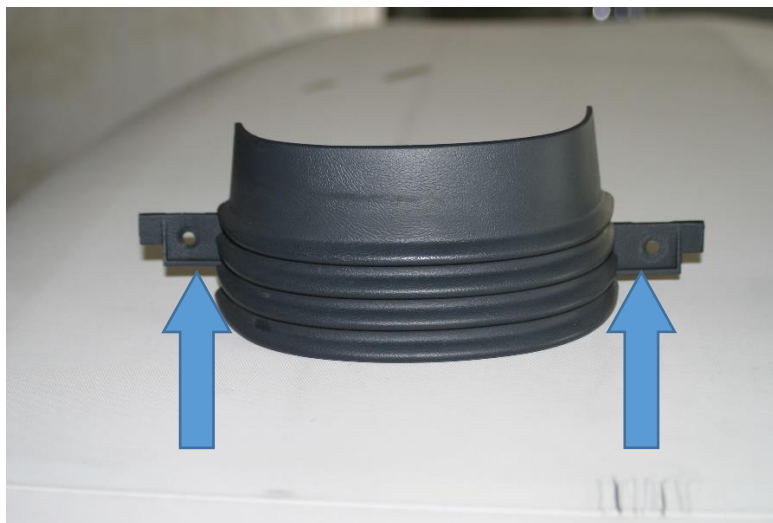
1. Remove the screws holding the Tilt Cover in place on either side of the cover. After removing the two screws, the cover will drop down. Screw hole locations indicated by the blue arrows Picture 2.

Picture 2: Blue arrows show screw locations in tilt cover

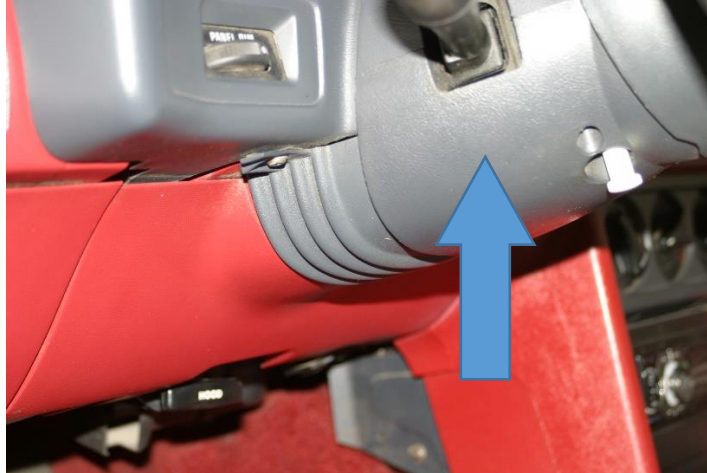
- Remove the 3 Phillips screws located in the lower steering column cover as indicated by the blue arrows in Picture 3. The screws are long and connect into the top steering column cover.

Picture 3: Lower steering column cover as indicated by the blue arrow

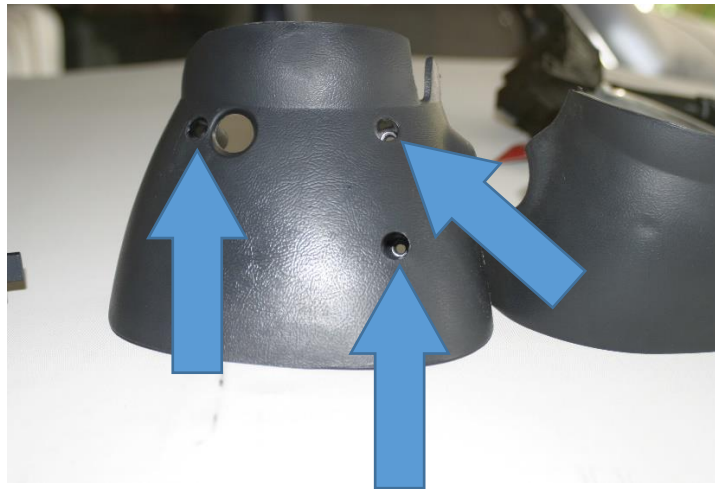
Picture 4: Blue arrows show screw Locations in lower steering column cover

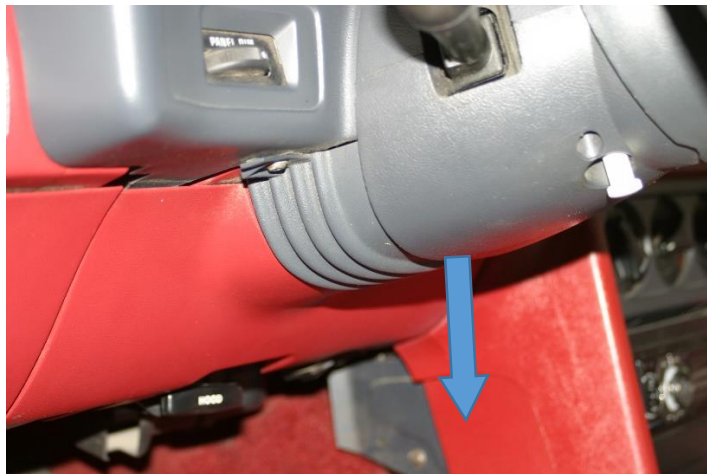
- Gently pull down on the front of the lower cover to release the snap retention in the plastic. The cover can be removed from the steering column by tilting it down, easing it off the key release then moving it toward the front of the car.

Picture 5: Location to help release the snap feature.

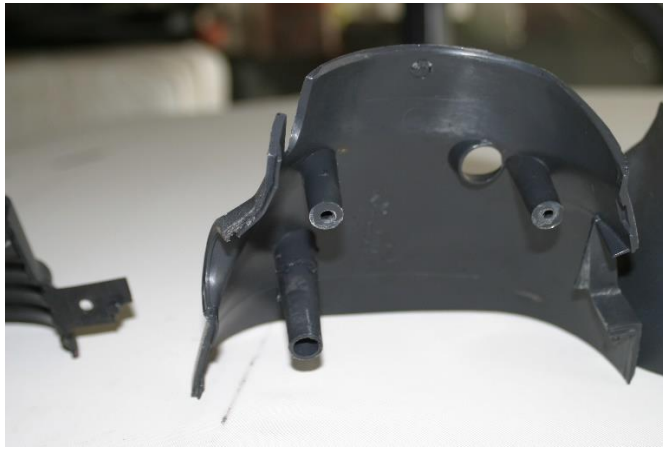
Picture 6: Backside of steering column cover.

The screw location may catch on steering column parts during removal. Go slowly.

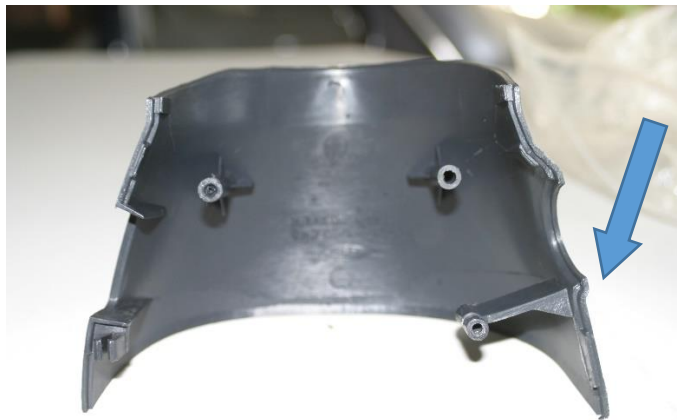
4. Gently remove the top steering cover expose the turn signal by lifting the front up and easing the plastic around the ignition/starter switch. This may take some small gentle movements as it's moved. Once released move it away from the steering wheel to remove the rear from under the rear column covers.

Picture 7: Three steering column screws connect into the top cover.

Passenger side ignition switch indicated by the blue arrow may get caught during removal.

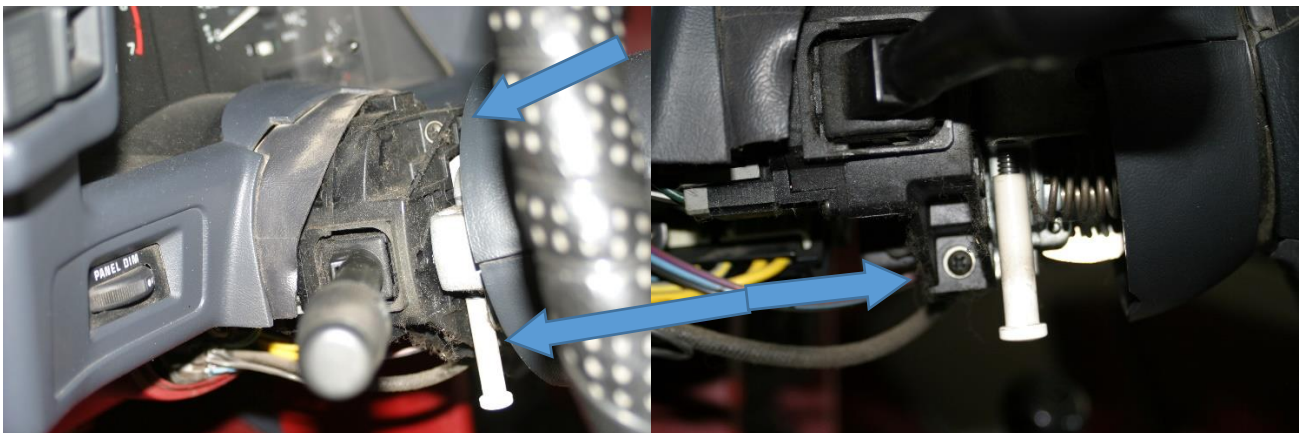
5. The original turn signal is exposed, remove the 2 screws holding the turn signal onto the steering column.

Picture 8 and 9: Original turn signal with screw locations

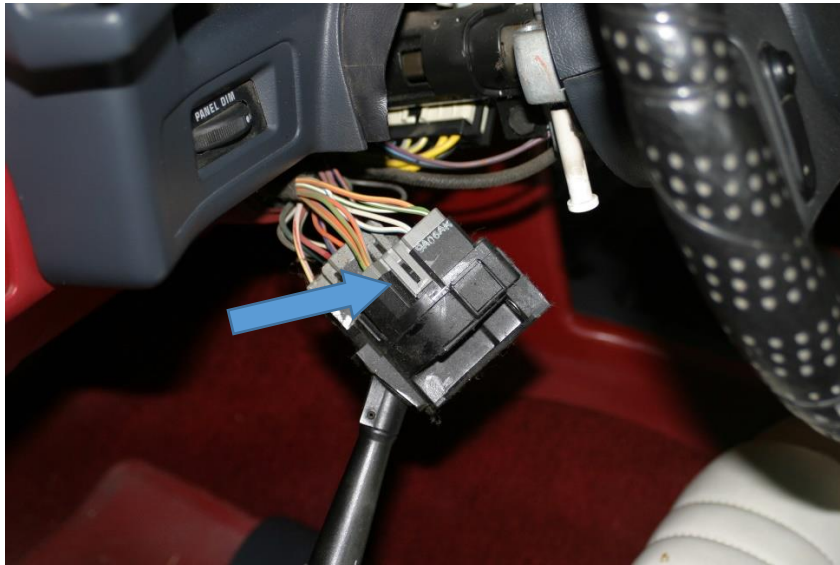
- The turn signal can be easily removed from the column so that the three cable harness connectors can be removed. The blue arrow indicates one of the harness clips. There are two for each of the 3 cable connectors. Be careful as the plastic may be brittle and old and can easily break. Gently work each back lifting just enough to clear the retaining feature until the connector releases.

Picture 10: Old turn signal ready for dis-connection

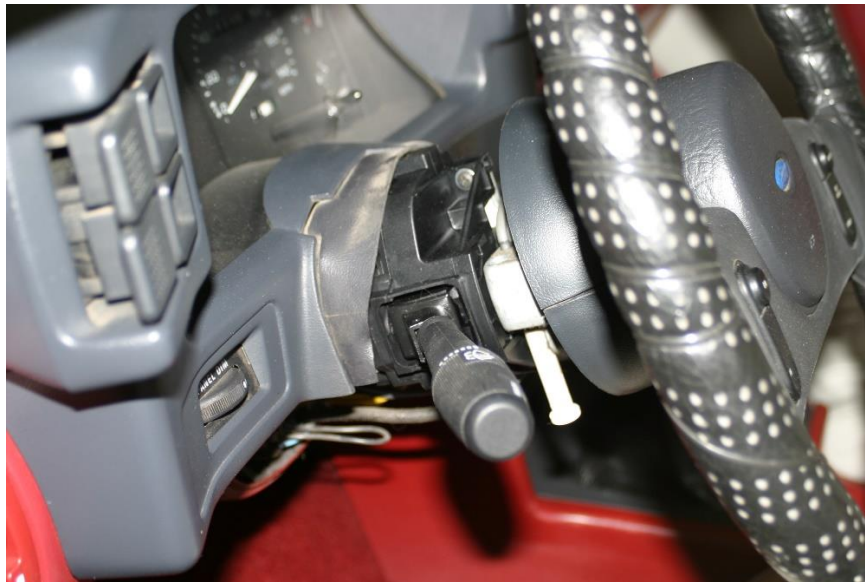
- Connect three connectors to the new turn signal. Each is shaped to allow only 1 connection position.
- Install turn signal back into the location and attach the two screws using the Phillips screwdriver. Tighten hand tight.

Picture 11: New turn signal installed

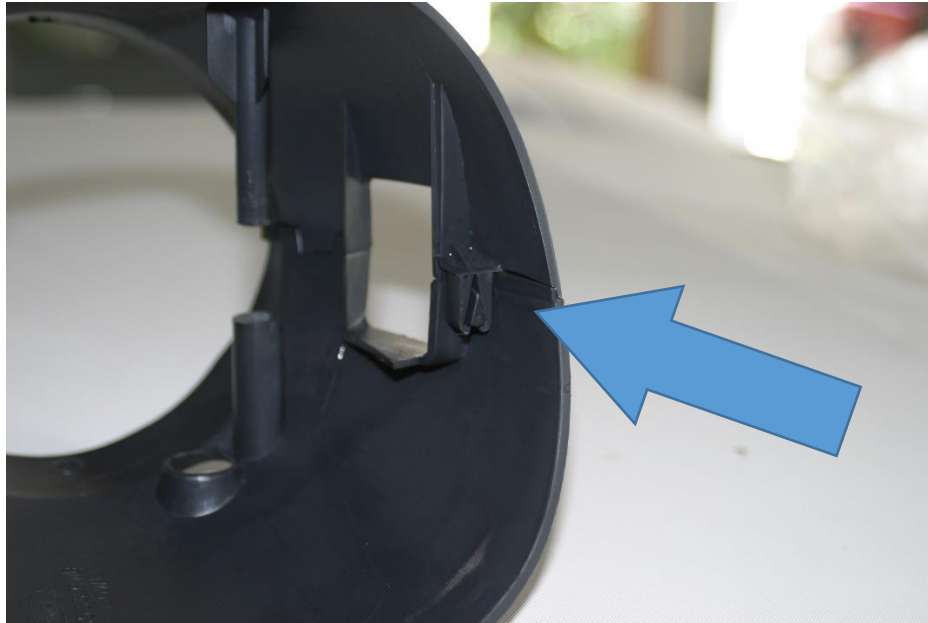
10. Prior to installing top and bottom steering column cover, view the forward snap feature that keeps the two parts together on the front. This feature must be aligned and gently snapped together during reassembly.

Picture 12: Steering column cover forward snap feature

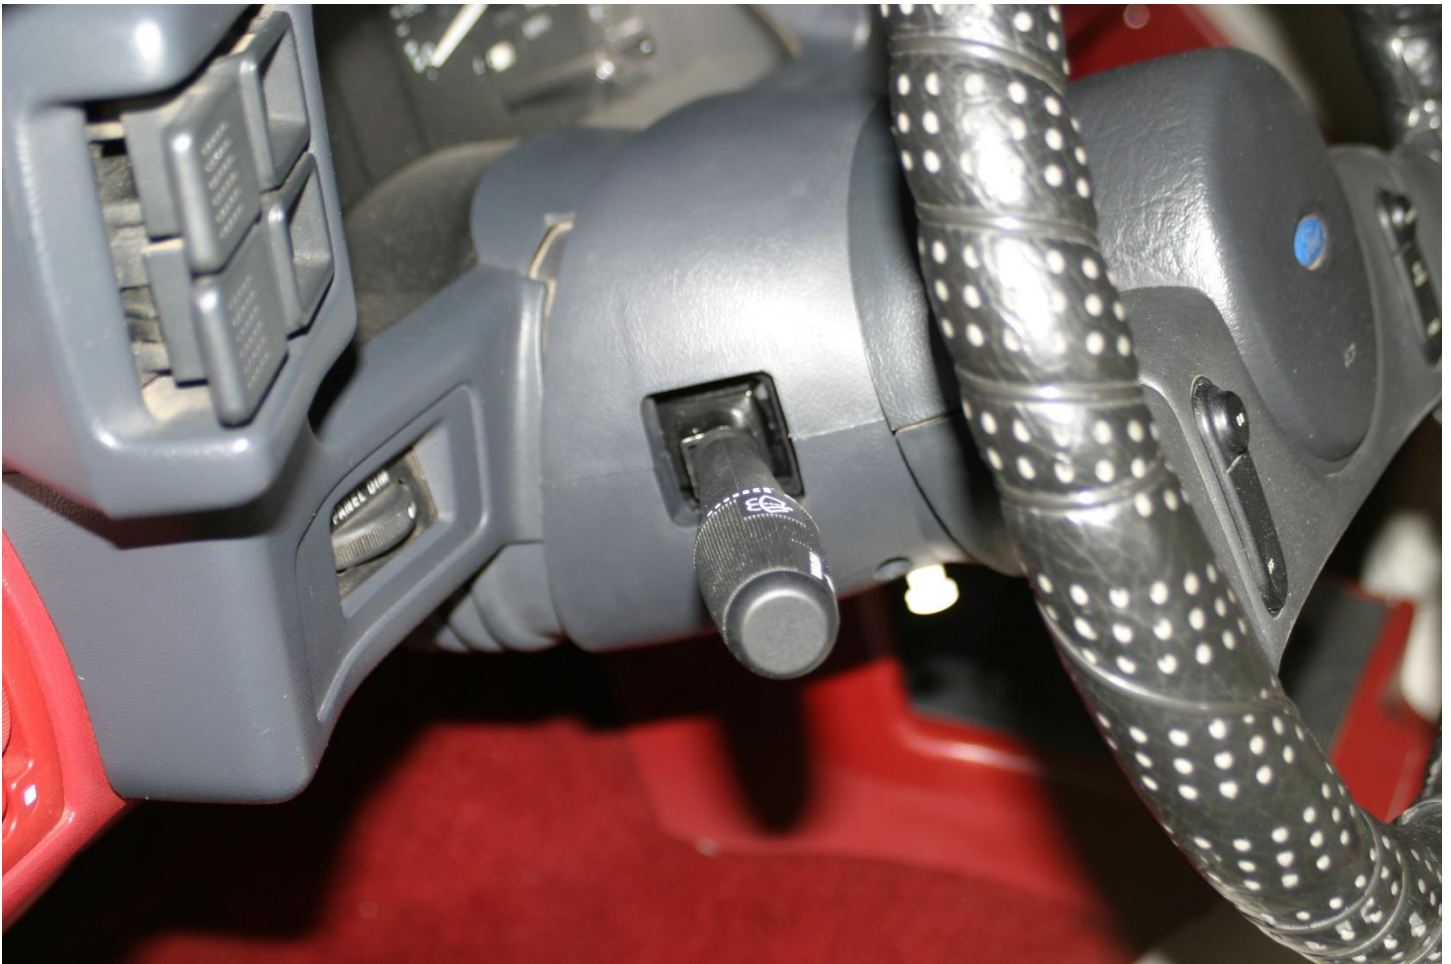
Picture 14: Turn signal installed
