# DECKLID PANEL

(2015-2020 MUSTANG GT)

## INSTALLATION INSTRUCTIONS

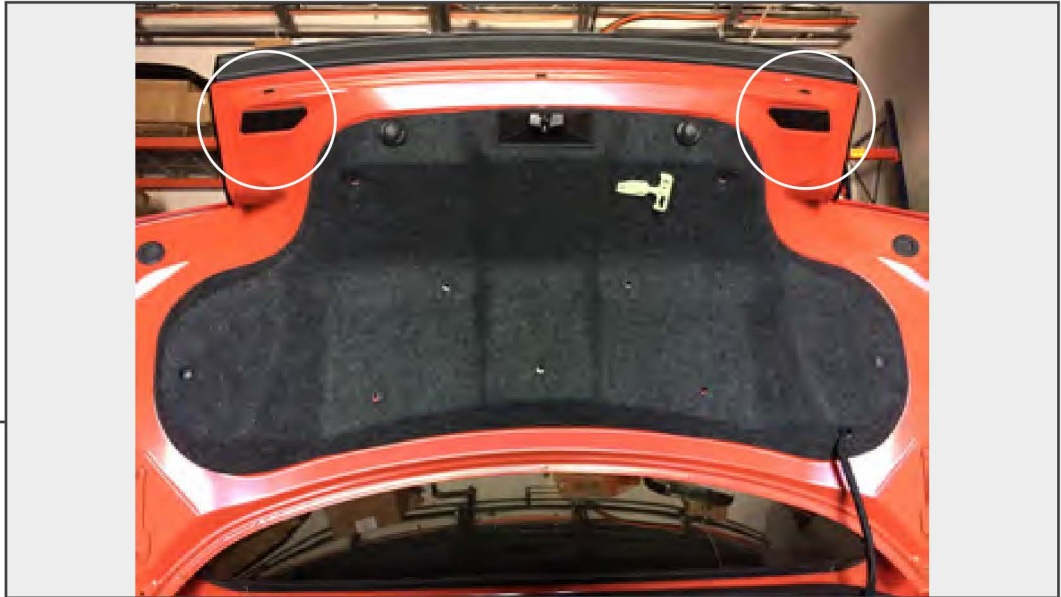
## STEP 1

Using the Trim Panel Removal Tool, gently remove the caps covering the decklid panel bolts. Remove the (4) 7mm bolts, taking your time so they don't accidentally fall between inner and outer layers of the panel.

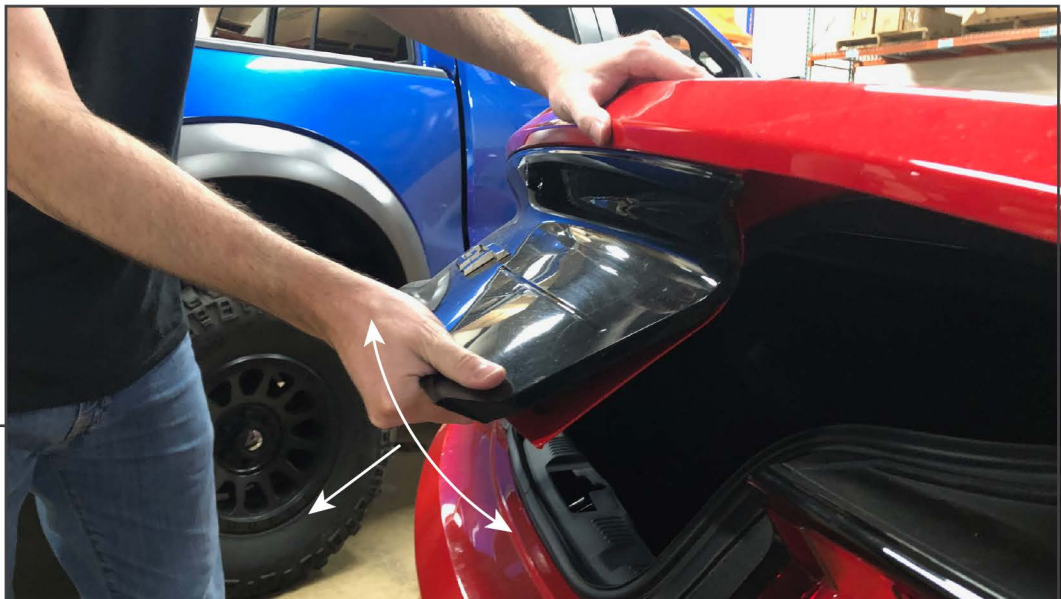
## STEP 2

To release the top clips of the decklid panel, start on the left or right hand side and grab the bottom edge of the panel, which should be loose since you've removed the (4) 7mm bolts. Gently rotate the panel up and down while pulling light towards you, gradually increase pulling force as necessary. This process will release the (4) metal clips at the top of the decklid panel, but there are still (2) plastic clips directly next to the reverse camera that will need to be release by removing the trunk lid liner in the next step. **AGGRESSIVE PULLING CAN CAUSE THE SHEET METAL TO BEND.**

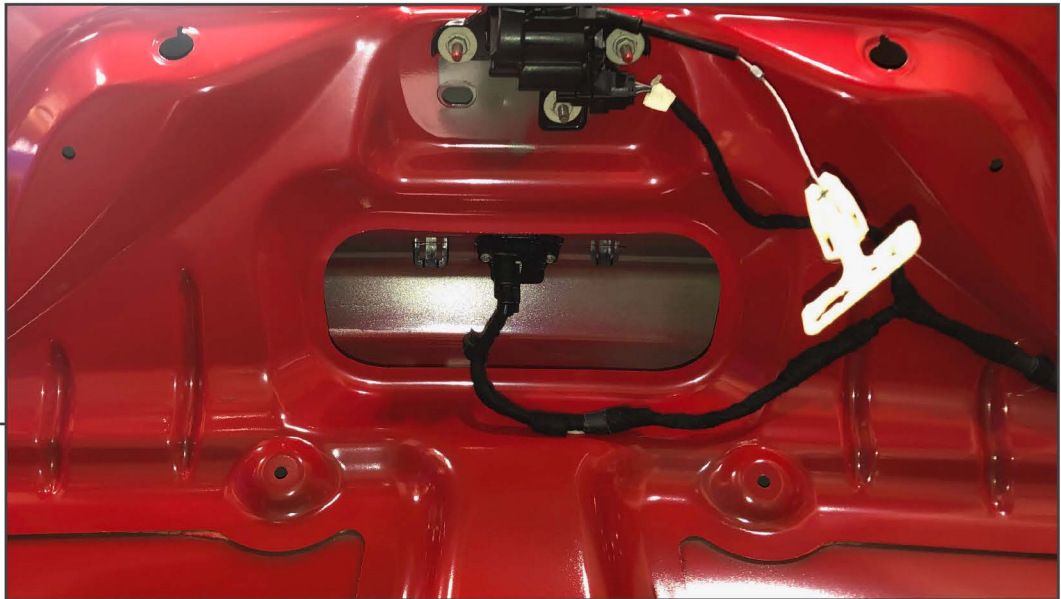
### STEP 3

Remove the (9) push rivets, (2) rubber bumpers, and trunk latch trim to remove the trunk lid liner. Once the liner is removed you will have access to the (2) remaining clips holding the decklid panel and the reverse camera wiring harness. Release the clips, unplug the harness, and remove the decklid panel from the vehicle.

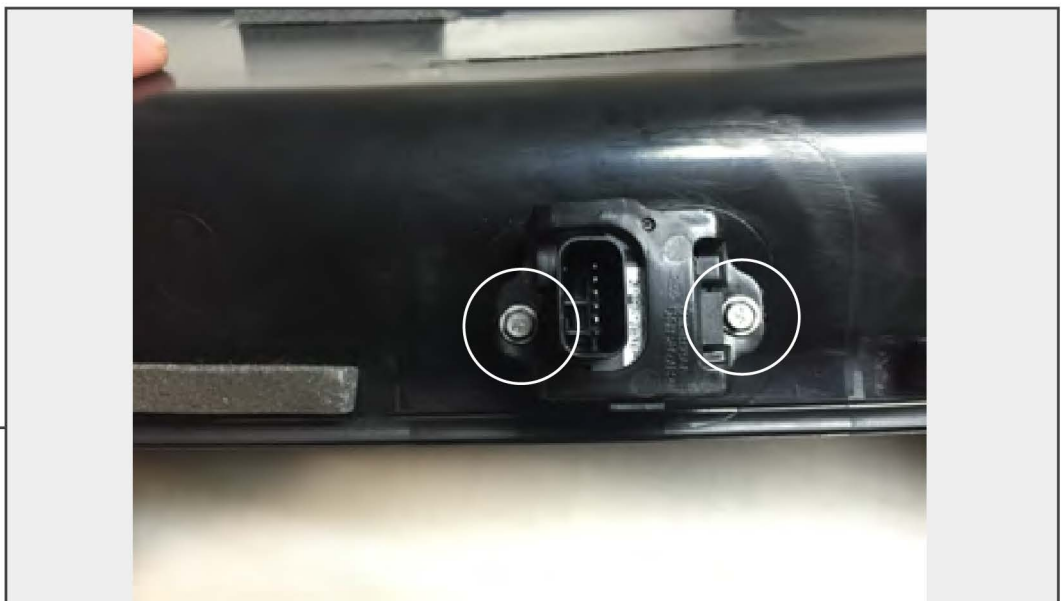
### STEP 4

Remove the (2) 5.5mm bolts on either side of the reverse camera and reinstall the assembly onto the MMD Decklid Panel, reusing the factory bolts. Make sure you keep the same camera orientation or the image will be upside down.

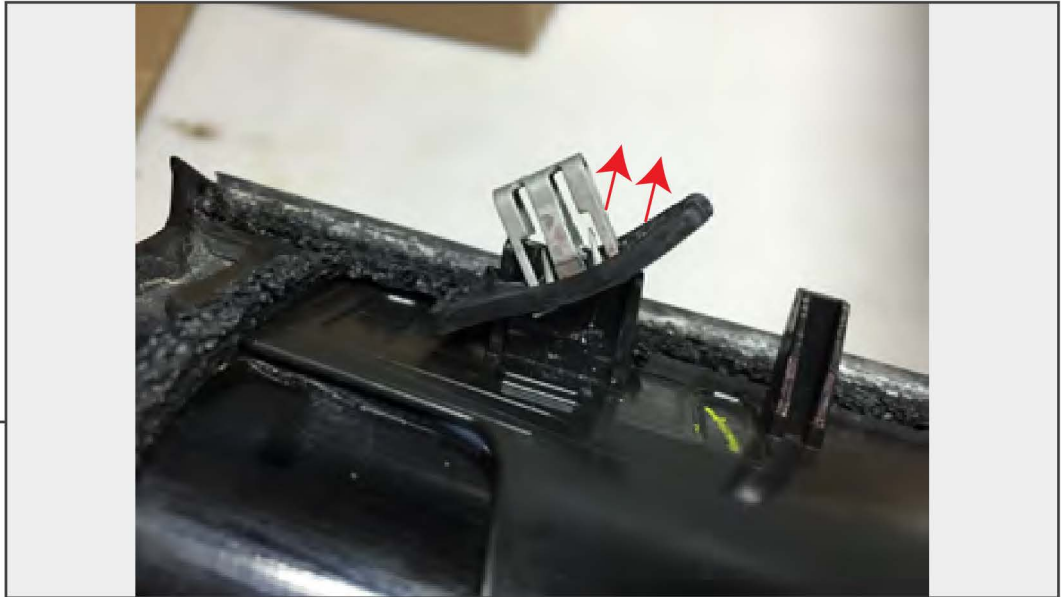
### STEP 5

Using a flat head screw driver, remove the metal clips from the factory decklid panel and reinstall them on the MMD Decklid Panel.

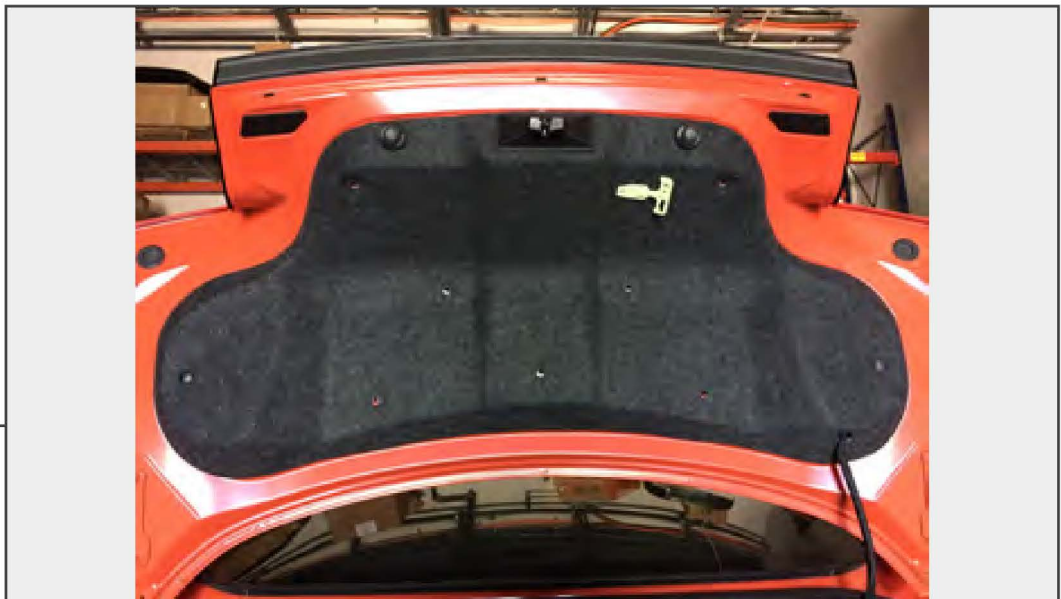
### STEP 6

Install the MMD Decklid Panel using the original factory locations. Start by snapping in the metal clips along the top of the panel, then install the (4) 7mm factory bolts. Lastly, reconnect the wiring harness to the reverse camera and reinstall the trunk lid liner.
