# Steeda X5 Ball Joint Installation Instructions 555-8108

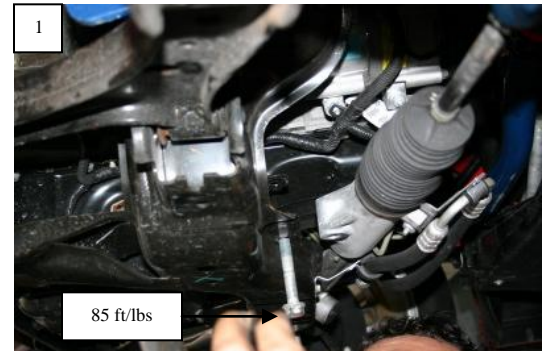
1. Raise the entire vehicle. If working from the floor, secure with jack stands. Remove the two front wheels.
2. Remove the two bolts holding the steering rack to the K-member. This will allow you to move the steering rack and gain access to the front control arm bushing. (Pic. 1)
